YMMS: 2006 Lexus GS 300 May 2, 2024

MIL "ON" DTC P0751

TECHNICAL SERVICE BULLETIN

Reference Number(s): L-SB-0076-09 Rev1, Date of Issue: May 13, 2010

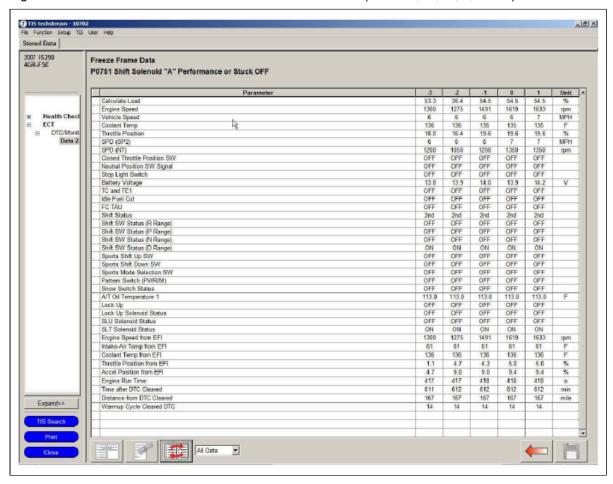
- 2. On vehicles with the original ECM (PCM) installed in the vehicle, 5 frames of Freeze Frame Data (titled -3, -2, -1, 0, and +1) will NOT be present and review of FFD values may not confirm which DTC set first.
 - Fig: Freeze Frame Data For P0751 With 5 Frames Of Data (Titled -3, -2, -1, 0, And 1)

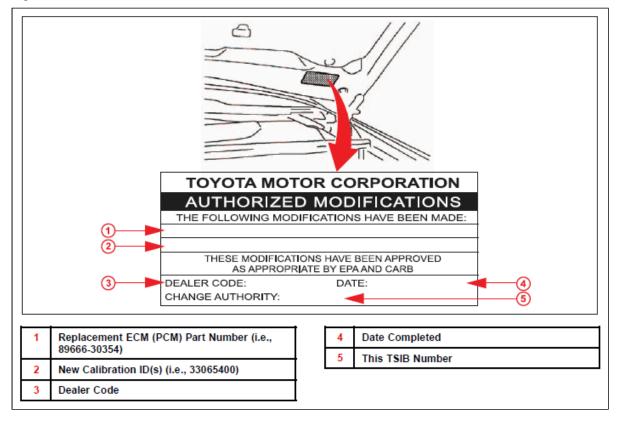
Fig: Location Of Authorized Modifications Label

If an Authorized Modifications Label is affixed to the vehicle in the location shown in Figure, this can assist in determining which Repair Procedure is applicable.

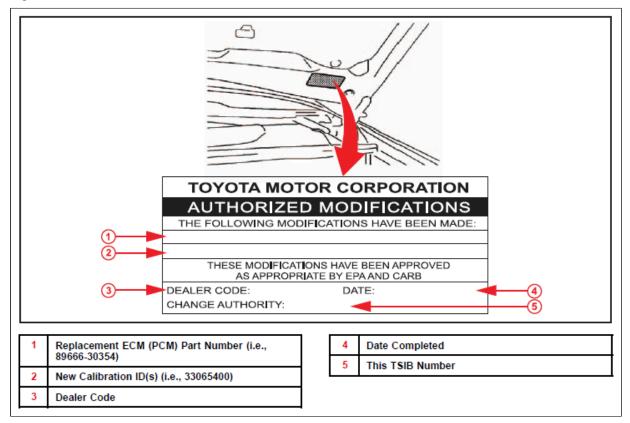
Fig: Location Of Authorized Modifications Label On 2006 GS 300

- 1. Confirm the calibration ID is applicable based on the Calibration Identification Chart in this bulletin.
- 2. Check for the Authorized Modifications Label affixed to the vehicle in the location shown in Figure. Confirm if the ECM (PCM) calibration has been updated. If the calibration ID listed is NOT the latest ECM (PCM) calibration go to step 3.

- 4. Install the Authorized Modifications Label.
 - A. Using a permanent marker, enter the following information on the label:
 - A. ECM part number [Refer to the Parts Information section for the CURRENT PART NUMBER]
 - B. Calibration ID(s) [Refer to the Calibration Identification Chartfor the NEW CALIBRATION ID]
 - C. Dealer Code
 - D. Repair Date
 - E. Change Authority [This TSIBnumber]
 - B. Affix the Authorized Modifications Label to the vehicle at the location shown in Figure. The Authorized Modifications Label is available through the MDC, P/N 00451-00001-LBL.
- 5. The repair is complete. Test drive the vehicle to confirm normal operation.
