Service Bulletin

PRELIMINARY INFORMATION

Subject: Loss of Communication with Allison Transmission Control Module (TCM), Intermittent Transmission Hesitation, Reduced Torque, Range Inhibit, Clunk, Stuck in Gear or in Neutral, Won't Shift, DTC P0880 and/or U0101 Set (Inspect for Electrostatic Discharge (ESD) from Aftermarket Serpentine Belts and/or Added Equipment, Install OEM Belt, Relocate TCM)

Models: 2007-2011 Chevrolet Silverado
2007-2011 GMC Sierra
Equipped with Allison® A1000 Automatic Transmission (RPO MW7)

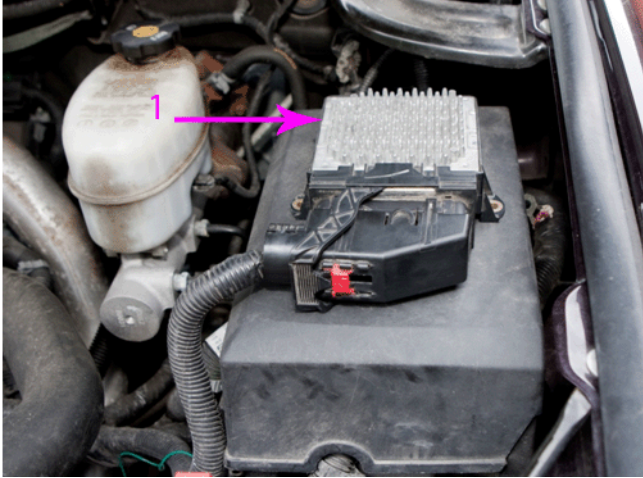
Important: DO NOT relocate the transmission control module (TCM) if aftermarket equipment HAS NOT been installed on the engine.

Relocate the TCM ONLY if an additional or longer accessory drive belt has been installed on the engine, resulting in the drive belt being closer to the TCM.

Relocating the TCM on a vehicle that has not been modified, WILL NOT correct the DTCs and may result in a comeback.

Note: Early in the 2011 model year, the TCM wire harness was shortened and may prevent relocating the TCM. If the wire harness on a 2011 vehicle is too short to relocate the TCM, the TCM should be replaced.

6. Relocate the TCM (1) to the top of the UBEC cover and secure it using a heavy duty adhesive or Velcro® “hook and loop fastener”. DO NOT use push pins as fasteners, they will compromise the water resistance of the UBEC cover.
